BOW DECONSTRUCTION UPDATE

DATE: 8/12/ 2011

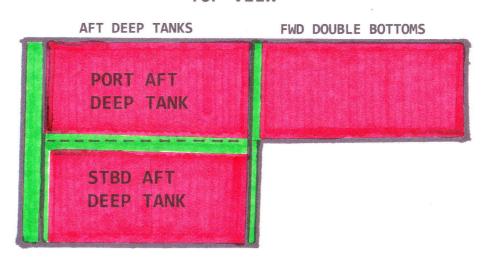
TOP VIEW

PORT PROFILE

BUNKER OIL WAS

RELASED AND

CAPTURED BY

SAUSAGE BOOM

WHEN CUTTING

PORT AND STBD

DOUBLE BOTTOM

VENT PIRES AND

SOUNDING TUBES
